**Flood Control Project Maintenance
Levee Inspections**
LMA District Cover Sheet
Spring 2018 Levee Inspection Results

Reclamation District No. 2063 Crows Landing

Waterway			Bank	Unit Miles
Unit No. 01 San Joaquin River			Right	10.44
	Spring (March - May)	Summer (June - August)	(September - November) Fall	Winter (December - February)
Unit Maintenance Rating (Fall Only)				
Date of Inspection	3/27/2018 - 3/27/2018			
DWR Inspector	Richard Willoughby			
Accompanied By	Joe Sallaberry RD2063

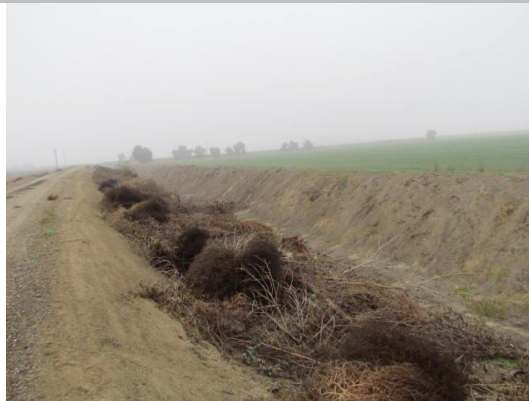
Photo 1 of 3 : SP_2018_RD2063_112_18_20180307_00001.jpg

LM Start	0.00	Rating **	U	Issue No.	18 (cont)
LM End	1.30	Issue Type +	En	Location *	LS

Looking north at ditch on landside berm and toe.

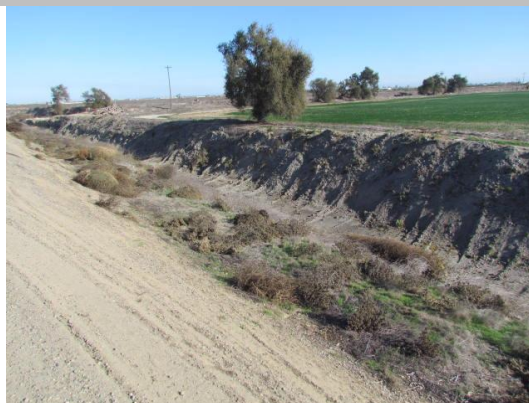
Photo 2 of 3 : SP_2018_RD2063_112_18_20180307_00002.jpg

Looking northeast at canal-ditch on landside berm.

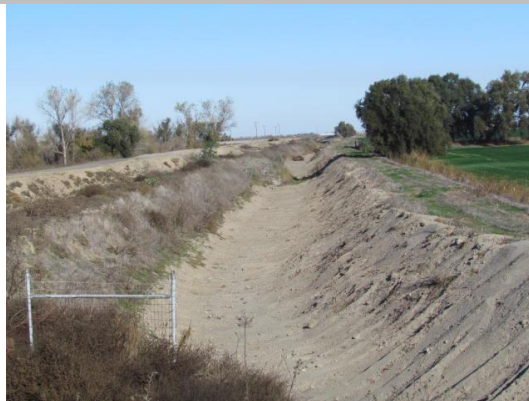
Photo 3 of 3 : SP_2018_RD2063_112_18_20180307_00003.jpg

LM Start	0.00	Rating **	U	Issue No.	18 (cont)
LM End	1.30	Issue Type +	En	Location *	LS

Looking south at canal-ditch at landside berm and toe.

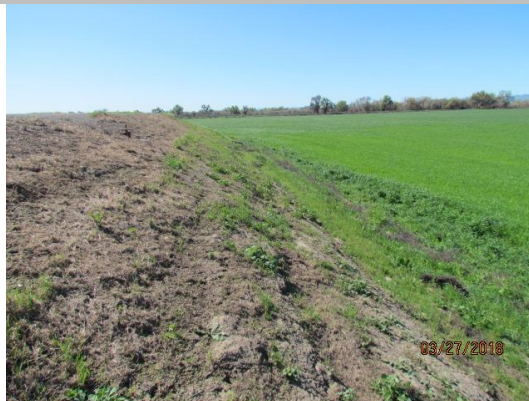
Photo 4 of 4 : SP_2018_RD2063_112_59_20180328_00114.jpg

LM Start	1.83	Rating **	A/W	Issue No.	59 (cont)	
LM End	1.93	Issue Type +	Ma	Location *	WS	
Category	Earthen Levee			GPS Latitude/Longitude		
				Start		End
Item	Erosion / Bank Caving			37.457653 °	37.456258 °	
				-121.033728 °	-121.033645 °	
DWR ID	DWR_RD2063_01_s_2017_59					
Comment Code						
E1 : Note and monitor erosion site.						
Inspector Comment						
Minor erosion at waterward slope was repaired.

Looking upstream at repaired site. (Spring 2018)

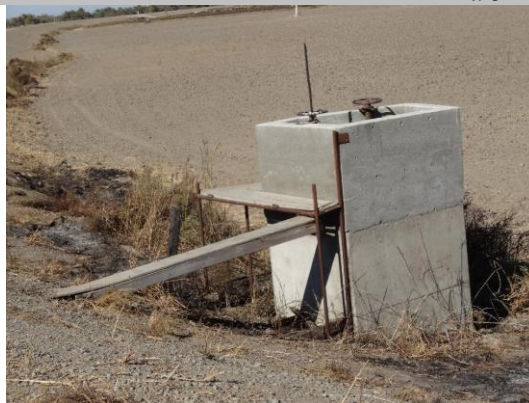
Photo 2 of 3 : UCIP_SP_2018_51823_43347.jpg

Comment Code					
Inspector Comment					
FS_ID:51823					
DS_ID:22081					
EP_NO: N/A					
Repair Type: No Action Needed					
Crossing Status: Found					
UCIP Comments: - concrete standpipe on waterside toe.- concrete distribution box on landside.- an alfalfa valve on waterside toe.					
FIELD_STRUCT_DESC: 30-inch corrugated metal gravity drainage pipe through the levee, 12 feet below the crown. Flap gate on the waterside (WS) end. Slide gate in a concrete distribution box on the landside (LS) end. Concrete U-shaped headwall on the WS end. [Additional Reference(s): DWR Levee Log, 1992. USACE San Joaquin O&M Manual 6, September 1961, (HLM 2.29)].					
FS Date: 11/5/2013

LS view: concrete distribution box and temporary walkway on levee toe.

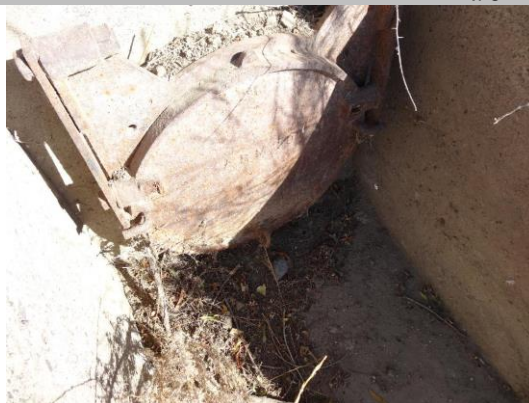
Photo 2 of 3 : UCIP_SP_2018_24435_43483.jpg

WS view: U shaped headwall outlet structure and pipe with flap gate.

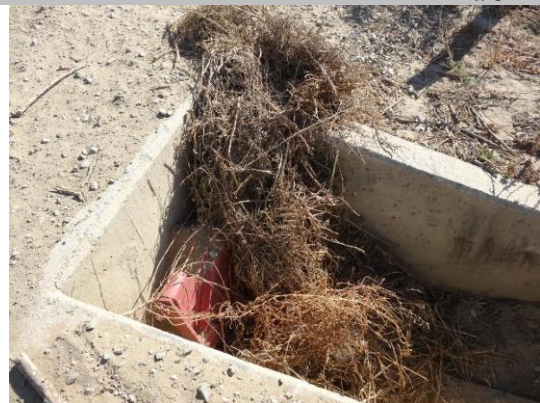
Photo 1 of 3 : UCIP_SP_2018_24443_43522.jpg

LM Start	2.93	Rating **	M	Issue No.	69
LM End	2.93	Issue Type +	Ma	Location *	
Category	Supplemental			GPS Latitude/Longitude	
				Start	End
Item	DWR UCIP LMA Responsibility			37.443871 °	37.443871 °
				-121.025775 °	-121.025775 °
DWR ID					
Comment Code					
Inspector Comment					
FS_ID:24443 DS_ID:22088 EP_NO: N/A Repair Type: Non-Urgent Crossing Status: Found UCIP Comments: - clear and clean debris FIELD_STRUCT_DESC: *ABANDONED* 24-inch corrugated metal gravity drainage pipe through the levee, 9.5 feet below the crown. Flap gate on the waterside (WS) end. Pipe open on the landside (LS) end. Concrete headwall on each end. [Additional Reference(s): DWR Levee Log, 1992. USACE San Joaquin O&M Manual 6, September 1961, (HLM 2.97)]. FS Date: 11/5/2013

WS view: U typed concrete headwall on levee slope.

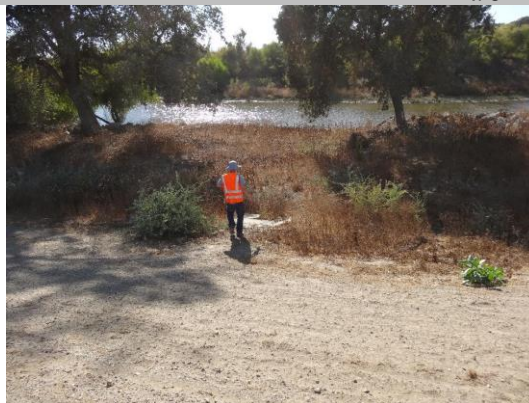
Photo 1 of 3 : UCIP_SP_2018_24469_43645.jpg

LM Start	3.29	Rating **	M	Issue No.	70	
LM End	3.29	Issue Type +	Ma	Location *		
Category	Supplemental			GPS Latitude/Longitude		
				Start	End	
Item	DWR UCIP LMA Responsibility			37.441213 °	37.441213 °	
				-121.021130 °	-121.021130 °	
DWR ID						
Comment Code						
Inspector Comment						
FS_ID:24469						
DS_ID:22089						
EP_NO: N/A						
Repair Type: Non-Urgent						
Crossing Status: Found						
UCIP Comments: - cleaning required in inlet pipe.- new flap gate						
FIELD_STRUCT_DESC: *ABANDONED* 24-inch corrugated metal						
gravity drainage pipe through the levee, 12.5 feet below the crown. Flap						
gate on the waterside (WS) end. Concrete headwall on each end.						
[Additional Reference(s): DWR Levee Log, 1992. USACE San Joaquin						
O&M Manual 6, September 1961, (HLM 3.33)].						
FS Date: 11/5/2013

WS view: U typed concrete headwall on levee toe

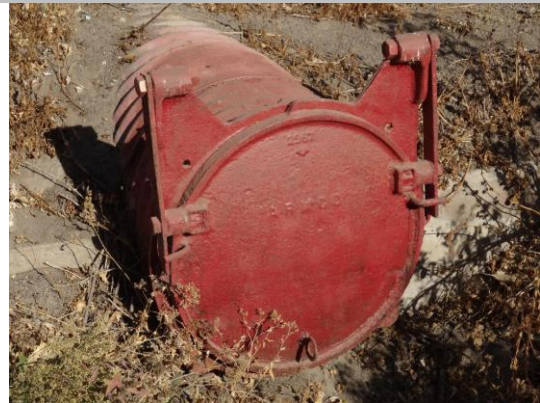
Photo 1 of 3 : UCIP_SP_2018_24485_43667.jpg

LM Start	3.64	Rating **	M	Issue No.	71
LM End	3.64	Issue Type +	Ma	Location *	
Category	Supplemental			GPS Latitude/Longitude	
				Start	End
Item	DWR UCIP LMA Responsibility			37.436845 °	37.436845 °
				-121.017826 °	-121.017826 °
DWR ID					
Comment Code					
Inspector Comment					
FS_ID:24485 DS_ID:22093 EP_NO: N/A Repair Type: Non-Urgent Crossing Status: Found UCIP Comments: - new flap gate on waterside.- cleaning and clearing of inlet box needed. FIELD_STRUCT_DESC: 24-inch corrugated metal gravity drainage pipe through the levee, 12 feet below the crown. Flap gate and concrete saddle on the waterside (WS) end. Concrete drop inlet box on the landside (LS) end. Installed by USACE in 1961. [Additional Reference(s): DWR Levee Log, 1992. USACE San Joaquin O&M Manual 6, September 1961, (HLM 3.69)]. FS Date: 11/5/2013

WS view: pipe, flap gate, and concrete saddle on levee slope

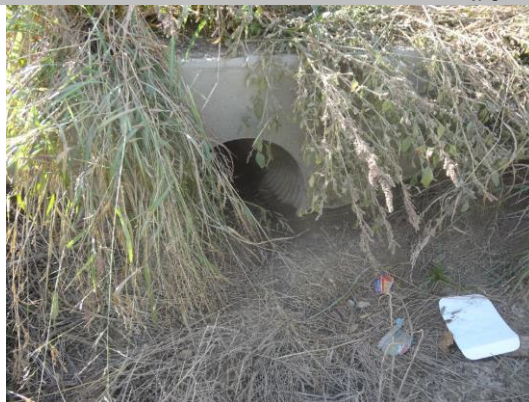
Photo 2 of 3 : UCIP_SP_2018_51821_43841.jpg

LS view: CM pipe and concrete headwall on levee toe.

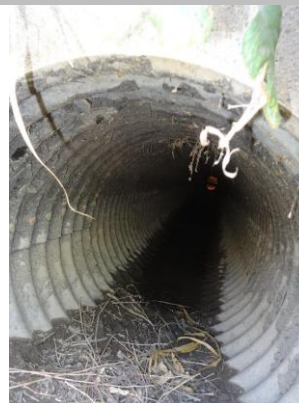
Photo 3 of 3 : UCIP_SP_2018_51821_43840.jpg

LS view: inside view of the CM pipe on levee toe.

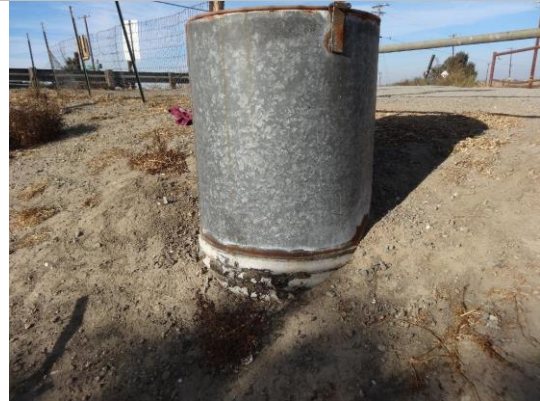
Photo 1 of 3 : UCIP_SP_2018_41746_43850.jpg

WS view: CMP riser on levee slope. Steel riser on top of CMP.

Comment Code						
Inspector Comment						
FS_ID:41746 DS_ID:22099 EP_NO: N/A Repair Type: Non-Urgent Crossing Status: Found UCIP Comments: Need to determine if annular space has been grouted or if repair/sleeving was done in accordance with a permit or Title 23. Slide gate not found in CM pipe riser on the waterward slope.Dense vegetation on waterside.Pipe only visible in CMP riser on waterside slope. FIELD_STRUCT_DESC: 24-inch corrugated metal irrigation discharge pipe through the levee, 10 feet below the crown. Smaller pipe sleeved through the 24-inch pipe. Slide gate in a corrugated metal pipe (CMP) riser on the waterside (WS) slope. Connects to a concrete pipe irrigation system. Installed by USACE in 1961. [Additional Reference(s): DWR Levee Log, 1992. USACE San Joaquin O&M Manual 6, September 1961, (HLM 4.16)]. FS Date: 11/5/2013

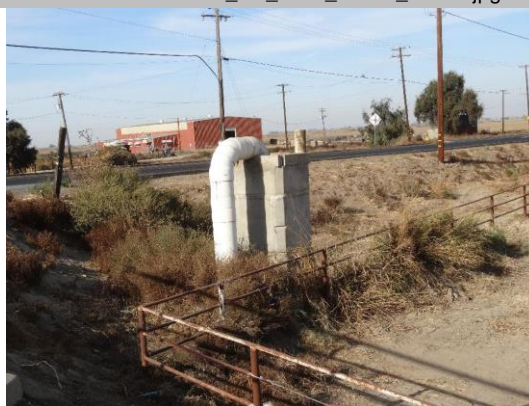
Photo 3 of 3 : UCIP_SP_2018_41746_43848.jpg

LS view: discharge pipe and concrete distribution box on levee toe.

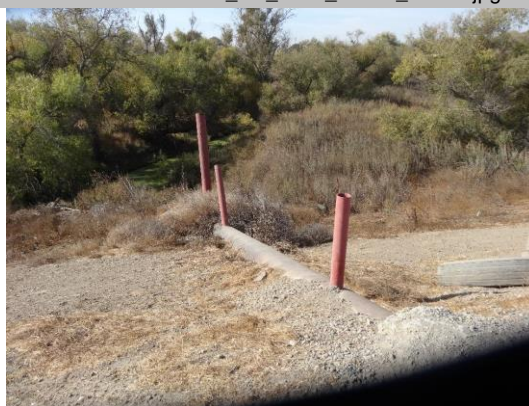
Photo 1 of 3 : UCIP_SP_2018_25025_45110.jpg

Comment Code					
Inspector Comment					
FS_ID:25025					
DS_ID:24732					
EP_NO: N/A					
Repair Type: Non-Urgent					
Crossing Status: Found					
UCIP Comments: - new pipe to pump.- overhead power line.- soil cover over the pipe seems not enough.					
FIELD_STRUCT_DESC: 24-inch steel drainage discharge pipe through the levee, immediately beneath the crown. A thin layer of dirt acts as cover for the pipe. Pump house on a steel structure in a drainage ditch on the landside (LS). Pump house and pipe on the LS look new. Old wooden walkway to the pump house. Three new air vents on the waterside (WS). Pipe opens on the WS. Exposed old pipe on the WS.					
FS Date: 11/6/2013

WS view: air vents (top- red) on exposed steel pipe.

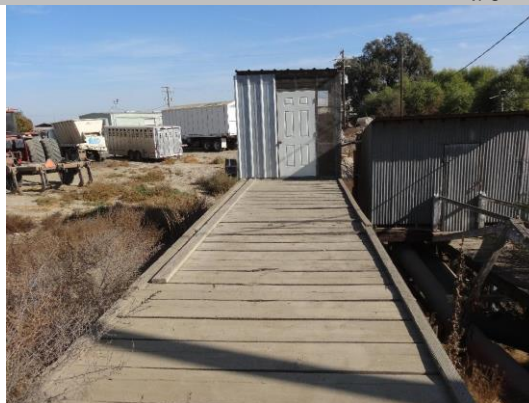
Photo 3 of 3 : UCIP_SP_2018_25025_45108.jpg

LS view: walkway to pump and pump house on levee slope.

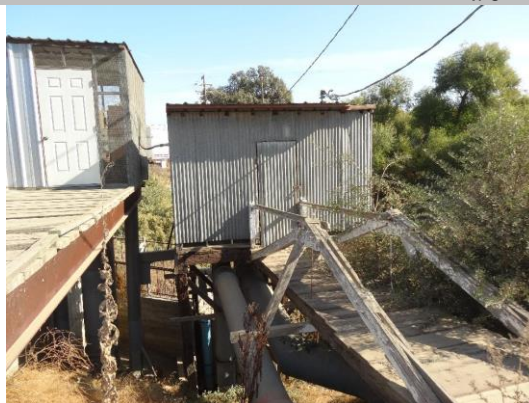
Photo 1 of 3 : UCIP_SP_2018_24603_43860.jpg

LS view: walkway to pump, pump house (right), and pipes on levee

Comment Code						
Inspector Comment						
FS_ID:24603 DS_ID:22100 EP_NO: 6721 Repair Type: No Action Needed Crossing Status: Found UCIP Comments: - Overhead power line.- looks new inlet pipes in pumphouse. FIELD_STRUCT_DESC: [Vivian Slough Pumping Plant] 1 of 3: 18-inch steel drainage discharge pipe through the levee, 2 feet below the crown. Pumps in a pump house and timber walkway on the landside (LS). Riser on the waterside (WS). (Plans to install a 30-horsepower pump and discharge pipe at existing pumping plant authorized under Permit No. 6721, 1969 - Reclamation District No. 2063. Plans to replace two 20-inch pipes through the levee at existing pumping plant authorized under Permit No. 6721-A, 1980 - Reclamation District No. 2063). [Additional Reference(s): DWR Levee Log, 1992, two 20-inch and one 22-inch pipes referenced. USACE San Joaquin O&M Manual 6, September 1961, (HLM 4.23), two 20-inch pipes referenced]. FS Date: 11/6/2013

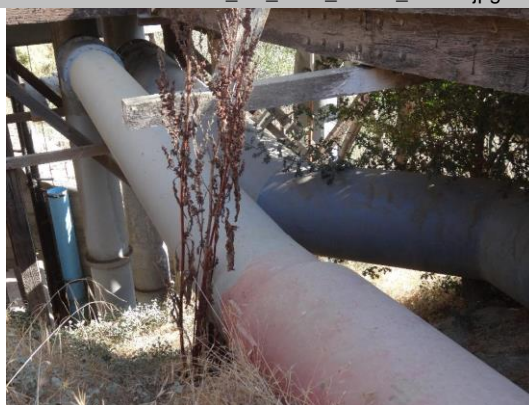
Photo 2 of 3 : UCIP_SP_2018_24603_43862.jpg

LS view: pipes (18" pipe - left, 20" pipe- right) under walkway and pump house on levee slope.

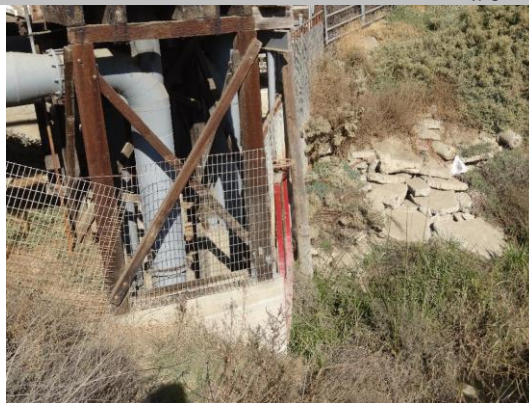
Photo 3 of 3 : UCIP_SP_2018_24603_43861.jpg

LS view: intake sump under pump house, and pipes in drainage ditch.

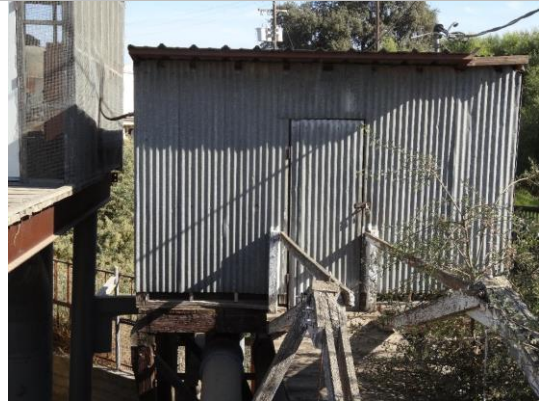
Photo 1 of 3 : UCIP_SP_2018_25027_45120.jpg

LS view: walkway to pump and pump house on levee slope.

Comment Code						
Inspector Comment						
FS_ID:25027 DS_ID:22121 EP_NO: 6721 Repair Type: No Action Needed Crossing Status: Found UCIP Comments: - new intake pipe to the pump.- overhead power line. FIELD_STRUCT_DESC: [Vivian Slough Pumping Plant] 3 of 3: 16-inch steel drainage discharge pipe through the levee, 3.6 feet below the crown. Pumps in a pump house and timber walkway on the landside (LS). Riser on the waterside (WS). (Plans to install a 30-horsepower pump and discharge pipe at existing pumping plant authorized under Permit No. 6721, 1969 - Reclamation District No. 2063. Plans to replace two 20-inch pipes through the levee at existing pumping plant authorized under Permit No. 6721-A, 1980 - Reclamation District No. 2063). [Additional Reference(s): DWR Levee Log, 1992, two 20-inch and one 22-inch pipes referenced. USACE San Joaquin O&M Manual 6, September 1961, (HLM 4.23), two 20-inch pipes referenced]. FS Date: 11/6/2013

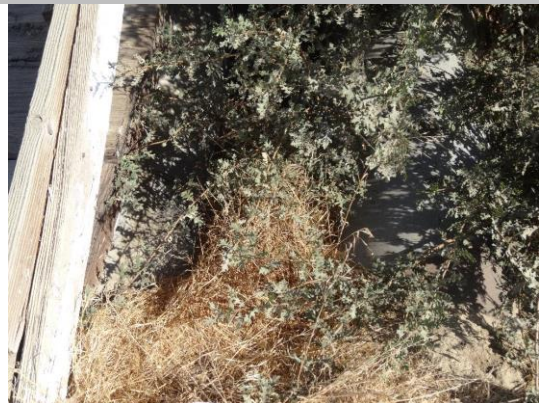
Photo 2 of 3 : UCIP_SP_2018_25027_45119.jpg

LS view: walkway to pump and pipe (right) on levee slope.

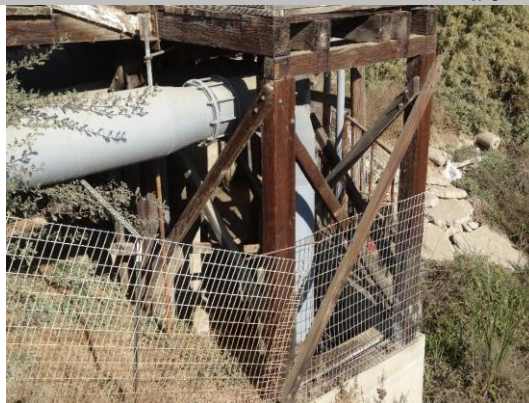
Photo 3 of 3 : UCIP_SP_2018_25027_45118.jpg

LS view: intake pipes and pump house on concrete sump in drainage ditch.

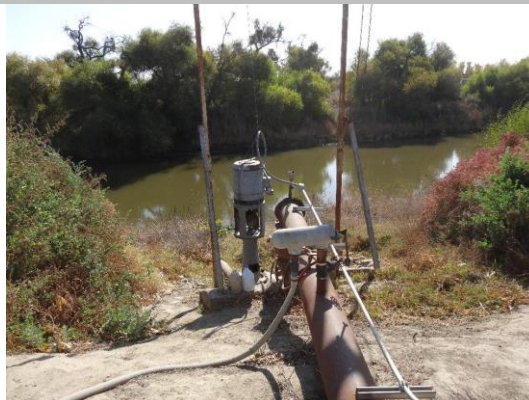
Photo 2 of 3 : UCIP_SP_2018_25028_45124.jpg

WS view: pump, pipe and other appurtenances on levee toe.

Comment Code						
Inspector Comment						
FS_ID:25028						
DS_ID:22103						
EP_NO: N/A						
Repair Type: Non-Urgent						
Crossing Status: Found						
UCIP Comments: Leaky pipe joint on landside where pipe daylights.Power pole on waterside.						
FIELD_STRUCT_DESC: 10-inch steel irrigation discharge pipe through the levee, 4 feet below the crown. Pump at the top of the riverbank. Gate valve on the waterside (WS) slope. Siphon breaker on the landside (LS) slope. Pipe daylights halfway down the LS slope and empties into a concrete standpipe at the LS toe. Installed by USACE in 1961. [Additional Reference(s): DWR Levee Log, 1992. USACE San Joaquin O&M Manual 6, September 1961, (HLM 4.65)].						
FS Date: 11/6/2013

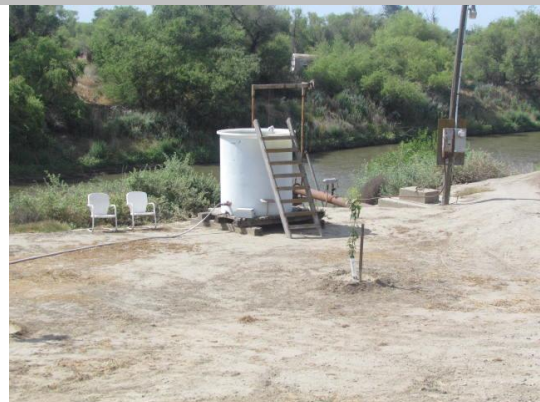
Photo 1 of 4 : SP_2018_RD2063_112_31_20180307_00004.jpg

LM Start	4.60	Rating **	M	Issue No.	31
LM End	4.60	Issue Type +	En	Location *	WS
Category	Earthen Levee			GPS Latitude/Longitude	
				Start	End
Item	Encroachments			37.429638 °	37.429638 °
				-121.005348 °	-121.005348 °
DWR ID	DWR_RD2063_01_s_2012_31				
Comment Code					
CR : Crops					
Inspector Comment					
Landowner planted grape vines and fruit trees and water tank on waterside berm without a permit from the CVFPB. Owner is continue to add to site. (Spring 2018)

Looking west at water tank on waterward berm.

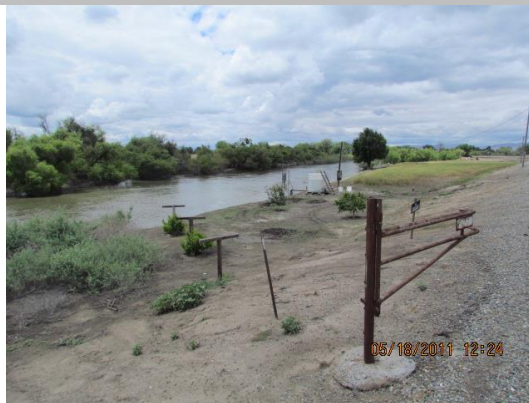
Photo 2 of 4 : SP_2018_RD2063_112_31_20180307_00005.jpg

Looking south at grapevines and fruit trees on waterside berm.

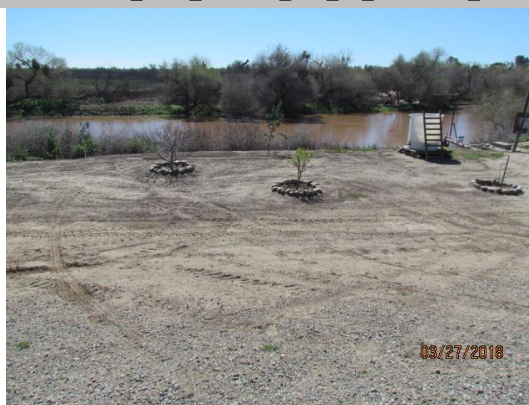
Photo 3 of 4 : SP_2018_RD2063_112_31_20180328_00115.jpg

Looking west at trees with retaining wall around trees. (Spring 2018)

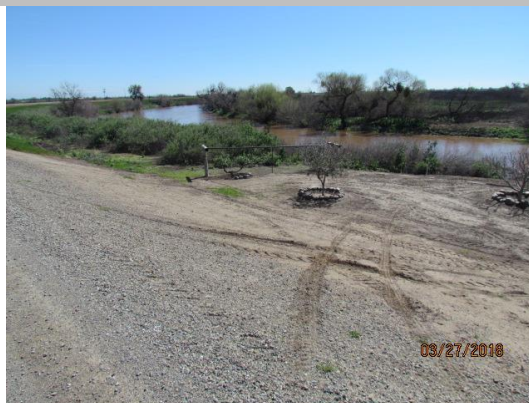
Photo 4 of 4 : SP_2018_RD2063_112_31_20180328_00116.jpg

Looking upstream at trees on waterward berm. (Spring 2018)

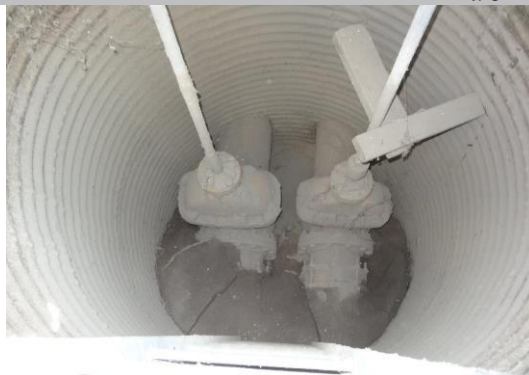
Photo 2 of 3 : UCIP_SP_2018_41669_45130.jpg

FS_ID:41669
DS_ID:22105
EP_NO: N/A
Repair Type: Non-Urgent
Crossing Status: Found
UCIP Comments: Abandoned pipe should be done so properly.- rubber pipe attached to steel pipe on waterside.- a concrete standpipe on landside too.- overhead power line.- abandoned pipe and pile structure. Abandoned timber walkway on waterside.
FIELD_STRUCT_DESC: 1 of 2: 12-inch concrete encased steel irrigation discharge pipe through the levee, 9 feet below the crown. Two pumps on a floating structure in the river. Two slide gates in a 72-inch corrugated metal pipe (CMP) riser on the waterside (WS) slope. Pipe discharges into a concrete distribution box on the landside (LS) toe. Installed by USACE in 1961. [Additional Reference(s): DWR Levee Log, 1992, 14-inch and 16-inch pipes referenced. USACE San Joaquin O&M Manual 6, September 1961, (HLM 5.13), 14-inch and 16-inch pipes referenced].
FS Date: 11/6/2013

WS view: two gate valves inside CMP riser on levee slope.

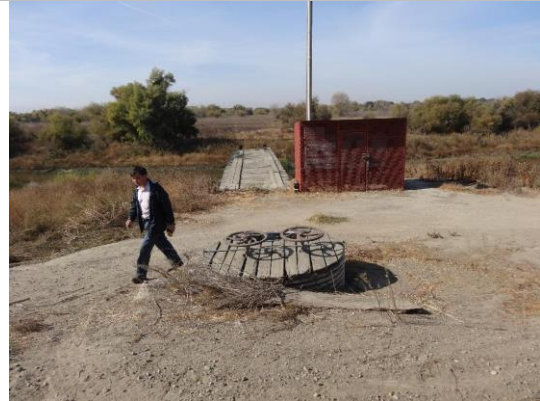
Photo 1 of 3 : UCIP_SP_2018_41670_43905.jpg

Comment Code					
Inspector Comment					
FS_ID:41670 DS_ID:22123 EP_NO: N/A Repair Type: Non-Urgent Crossing Status: Found UCIP Comments: Any abandoned pipes should be verified as having been abandoned properly. - abandoned walkway, pile structure and steel pipe.- concrete standpipe on landside toe.- overhead power line. FIELD_STRUCT_DESC: 2 of 2: 12-inch concrete encased steel irrigation discharge pipe through the levee, 9 feet below the crown. Two pumps on a floating structure in the river. Two slide gates in a 72-inch corrugated metal pipe (CMP) riser on the waterside (WS) slope. Pipe discharges into a concrete distribution box on the landside (LS) toe. Installed by USACE in 1961. [Additional Reference(s): DWR Levee Log, 1992, 14-inch and 16-inch pipes referenced. USACE San Joaquin O&M Manual 6, September 1961, (HLM 5.13), 14-inch and 16-inch pipes referenced]. FS Date: 11/6/2013

WS view: CMP riser, abandoned walkway, power pole on levee slope.

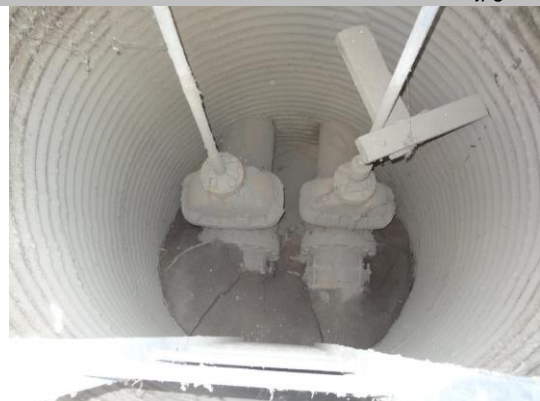
Photo 2 of 3 : UCIP_SP_2018_41670_43904.jpg

WS view: two gate valves inside CMP riser on levee slope.

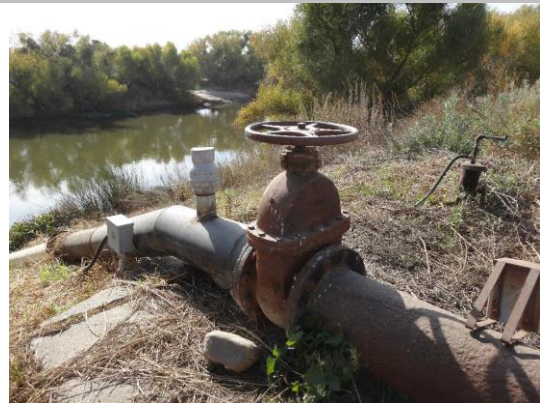
Photo 1 of 3 : UCIP_SP_2018_24628_43938.jpg

Comment Code						
Inspector Comment						
FS_ID:24628 DS_ID:22108 EP_NO: 4062 Repair Type: Non-Urgent Crossing Status: Found UCIP Comments: Abandoned pipe also found adjacent to this pipe. Needs proper abandonment.Soil erosion under pipe on waterside. No pipe visible on landside.Overhead powerline. FIELD_STRUCT_DESC: 12-inch polyvinyl chloride (PVC) irrigation discharge pipe through the levee, 3 feet below the crown. Floating pump in the river. Gate valve and air vent on the waterside (WS) berm. Service pole with overhead line on the WS shoulder. (Plans for an existing pump with discharge pipe through the levee authorized under Permit No. 4062, 1962 - John W. Greer). [Additional Reference(s): DWR Levee Log, 1992]. FS Date: 11/6/2013

WS view: steel pipe, gate valve, air vent on levee berm.

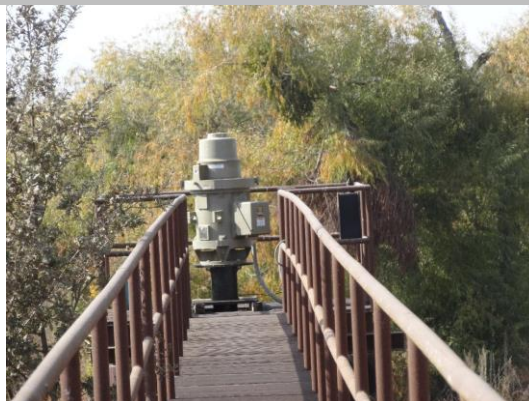
Photo 2 of 3 : UCIP_SP_2018_24629_43942.jpg

FS_ID:24629
DS_ID:22109
EP_NO: 13541
Repair Type: Non-Urgent
Crossing Status: Found
UCIP Comments: - erosion around CMP riser on waterside- no U type headwall found on landside.- no pipe found on landside.
FIELD_STRUCT_DESC: 16-inch steel irrigation discharge pipe through the levee, 10 feet below the crown. Pump on the riverbank. Gate valve in a corrugated metal pipe (CMP) riser on the waterside (WS) slope. Concrete U-shaped headwall on the landside (LS) end. Installed by USACE in 1961. (Plans to construct an elevated platform and replace a centrifugal pump with a new vertical pump on the riverbank authorized under Permit No. 13541, 1982 - Joaquin Cabral). [Additional Reference(s): DWR Levee Log, 1992. USACE San Joaquin O&M Manual 6, September 1961, (HLM 7.08), 10-inch pipe referenced].
FS Date: 11/6/2013

WS view: walkway to pump and pump on pile structure in the stream.

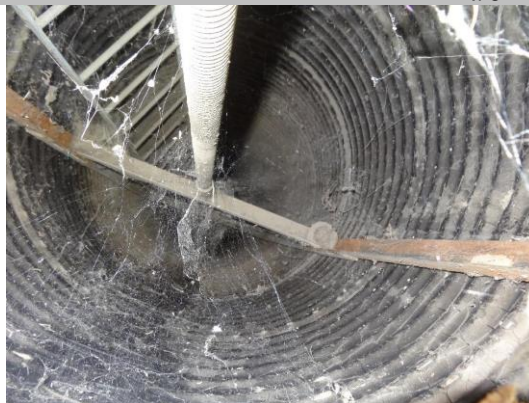
Photo 2 of 3 : UCIP_SP_2018_24632_43952.jpg

Comment Code						
Inspector Comment						
FS_ID:24632 DS_ID:22110 EP_NO: N/A Repair Type: No Action Needed Crossing Status: Found UCIP Comments: No pipe visible on landside.Flap gate not found on the waterside end. Concrete "U" headwalls not found on ends of pipe. FIELD_STRUCT_DESC: 36-inch corrugated metal gravity drainage pipe through the levee, 25.5 feet below the crown. Slide gate in a corrugated metal pipe (CMP) riser on the waterside (WS) slope. Flap gate on the WS end. Concrete U-shaped headwall on each end. Installed by USACE in 1961. [Additional Reference(s): DWR Levee Log, 1992. USACE San Joaquin O&M Manual 6, September 1961, (HLM 7.61)]. FS Date: 11/6/2013

WS view: slide gate in CMP riser on levee slope.

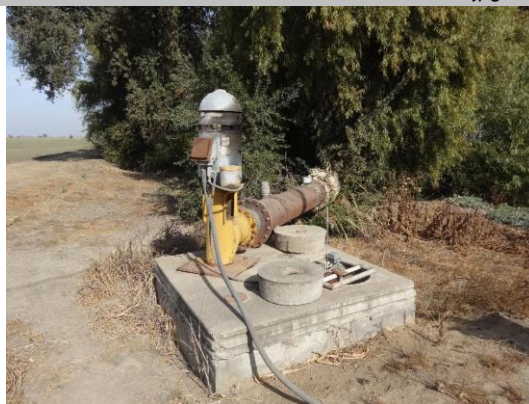
Photo 3 of 3 : UCIP_SP_2018_24632_43951.jpg

LS view: concrete distribution box on levee toe. Pump on the box discharges water into irrigation ditch.

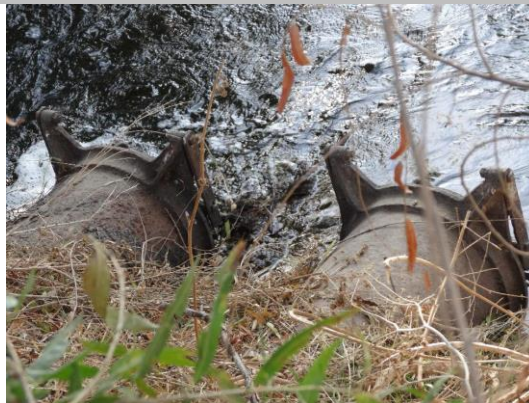
Photo 2 of 3 : UCIP_SP_2018_24651_44004.jpg

FS_ID:24651
DS_ID:22124
EP_NO: N/A
Repair Type: Non-Urgent
Crossing Status: Found
UCIP Comments: 10/27/2017 This structure is inspected annually under the Structure and Channel Summer Inspection (part of the Levee Inspection Program) conducted by the DWR Flood Project Integrity and Inspection Branch (FPIIB). (DWR UCIP - O. Magana)
- working during field inspection.- blocked siphon breaker.
FIELD_STRUCT_DESC: 1 of 2: 16-inch steel drainage discharge pipe through the levee, 3.5 feet below the crown. Siphon breaker in a corrugated metal pipe (CMP) riser on the waterside (WS) slope. Flap gate on the WS end. Pump on a timber pile structure on the landside (LS). Timber walkway from levee to pump structure. [Additional Reference(s): DWR Levee Log, 1992. USACE San Joaquin O&M Manual 6, September 1961, (HLM 8.60)].
FS Date: 11/6/2013

WS view: two flap gates on outfall pipe ends.

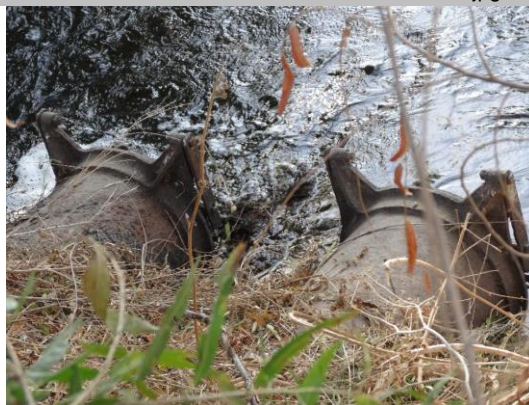
Photo 2 of 3 : UCIP_SP_2018_24652_44007.jpg

FS_ID:24652
DS_ID:22112
EP_NO: N/A
Repair Type: Non-Urgent
Crossing Status: Found
UCIP Comments: 10/27/2017 This structure is inspected annually under the Structure and Channel Summer Inspection (part of the Levee Inspection Program) conducted by the DWR Flood Project Integrity and Inspection Branch (FPIIB). (DWR UCIP - O. Magana)
- working during field inspection.- blocked siphon breaker.
FIELD_STRUCT_DESC: 2 of 2: 16-inch steel drainage discharge pipe through the levee, 3.5 feet below the crown. Siphon breaker in a corrugated metal pipe (CMP) riser on the waterside (WS) slope. Flap gate on the WS end. Pump on a timber pile structure on the landside (LS). Timber walkway from levee to pump structure. [Additional Reference(s): DWR Levee Log, 1992. USACE San Joaquin O&M Manual 6, September 1961, (HLM 8.60)].
FS Date: 11/6/2013

WS view: two flap gates on outfall pipe ends.

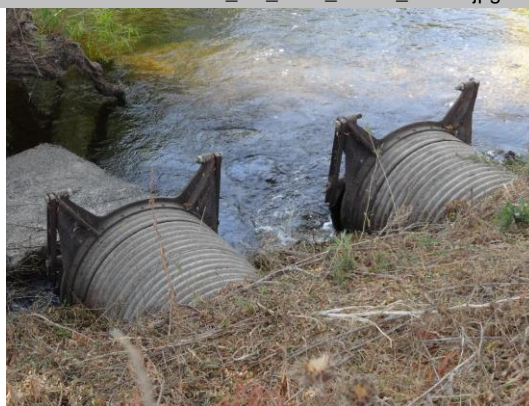
Photo 1 of 3 : UCIP_SP_2018_24650_44002.jpg

Comment Code						
Inspector Comment						
FS_ID:24650 DS_ID:22113 EP_NO: N/A Repair Type: No Action Needed Crossing Status: Found UCIP Comments: 10/27/2017 This structure is inspected annually under the Structure and Channel Summer Inspection (part of the Levee Inspection Program) conducted by the DWR Flood Project Integrity and Inspection Branch (FPIIB). (DWR UCIP - O. Magana) Working during field inspection. FIELD_STRUCT_DESC: [Reclamation District No. 2063 Pumping Plant] 1 of 2: 42-inch corrugated metal gravity drainage pipe through the levee, 18 feet below the crown. Slide gate in a corrugated metal pipe (CMP) riser on the waterside (WS) slope. Flap gate, concrete saddle, and apron on the WS end. Concrete headwall on the landside (LS) end. [Additional Reference(s): DWR Levee Log, 1992. USACE San Joaquin O&M Manual 6, September 1961, (HLM 8.60)]. FS Date: 11/6/2013

WS view: two flap gates on outfall pipe ends.

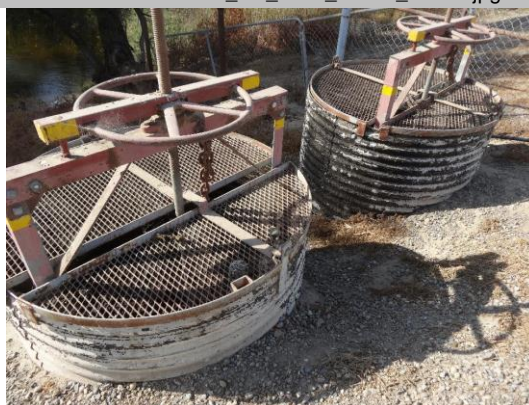
Photo 2 of 3 : UCIP_SP_2018_24650_44001.jpg

WS view: two slide gates in CMP risers on levee slope.

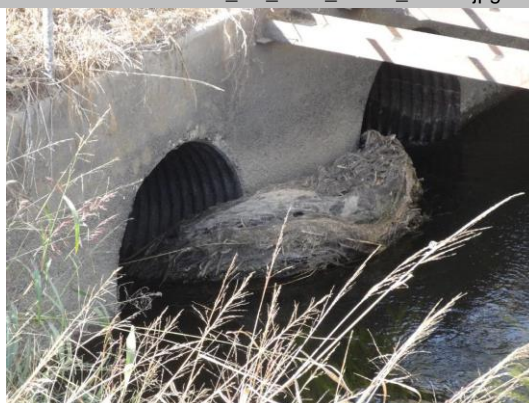
Photo 3 of 3 : UCIP_SP_2018_24650_44000.jpg

Comment Code						
Inspector Comment						
FS_ID:24650 DS_ID:22113 EP_NO: N/A Repair Type: No Action Needed Crossing Status: Found UCIP Comments: 10/27/2017 This structure is inspected annually under the Structure and Channel Summer Inspection (part of the Levee Inspection Program) conducted by the DWR Flood Project Integrity and Inspection Branch (FPIIB). (DWR UCIP - O. Magana) Working during field inspection. FIELD_STRUCT_DESC: [Reclamation District No. 2063 Pumping Plant] 1 of 2: 42-inch corrugated metal gravity drainage pipe through the levee, 18 feet below the crown. Slide gate in a corrugated metal pipe (CMP) riser on the waterside (WS) slope. Flap gate, concrete saddle, and apron on the WS end. Concrete headwall on the landside (LS) end. [Additional Reference(s): DWR Levee Log, 1992. USACE San Joaquin O&M Manual 6, September 1961, (HLM 8.60)]. FS Date: 11/6/2013

LS view: drainage pipes under walkway in drainage ditch.

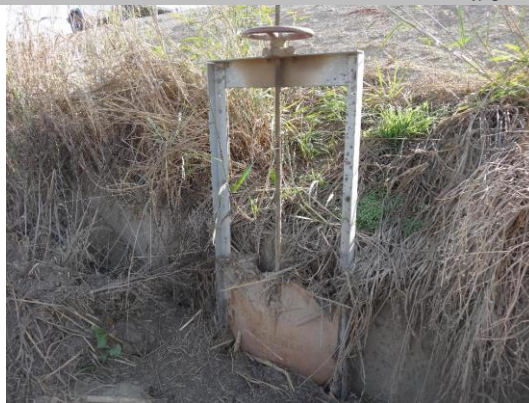
Photo 1 of 2 : UCIP_SP_2018_24638_43967.jpg

Comment Code					
Inspector Comment					
FS_ID:24638 DS_ID:22114 EP_NO: N/A Repair Type: No Action Needed Crossing Status: Found UCIP Comments: Flap gate and concrete "U" headwall not visible due to dense vegetation on waterside. FIELD_STRUCT_DESC: 24-inch corrugated metal gravity drainage pipe through the levee, 12 feet below the crown. Flap gate, concrete U-shaped headwall, and 7-foot-long grouted spillway on the waterside (WS) end. Slide gate and concrete headwall on the landside (LS) end. Installed by USACE in 1961. [Additional Reference(s): DWR Levee Log, 1992. USACE San Joaquin O&M Manual 6, September 1961, (HLM 9.21)]. FS Date: 11/6/2013

WS view: concrete headwall on levee end. Slide gate on pipe end.

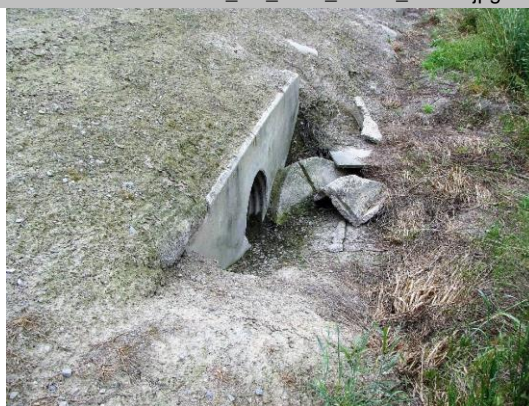
Photo 1 of 3 : UCIP_SP_2018_51825_77044.jpg

Comment Code					
Inspector Comment					
FS_ID:51825					
DS_ID:22115					
EP_NO: N/A					
Repair Type: No Action Needed					
Crossing Status: Found					
UCIP Comments: 04/11/2017 LS inlet has been cleared, as per DWR inspector Richard Willoughby. (K. Fazel - UCIP)11/06/2013 Landside inlet blocked by plywood. (P. Amatya - DWR)					
FIELD_STRUCT_DESC: 24-inch corrugated metal gravity drainage pipe through the levee, 5.6 feet below the crown. Flap gate and concrete U-shaped headwall on the waterside (WS) end. Concrete headwall on the landside (LS) end. Installed by USACE in 1961. [Additional Reference(s): DWR Levee Log, 1992. USACE San Joaquin O&M Manual 6, September 1961, (HLM 9.66)].					
FS Date: 4/11/2017

LS inlet as of 4/11/2017 levee inspection. Photo courtesy of DWR inspector Richard Willoughby.

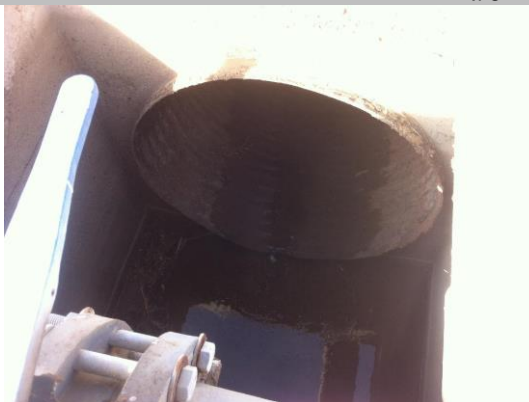
Photo 1 of 3 : UCIP_SP_2018_24644_43986.jpg

LM Start	9.94	Rating **	A/W	Issue No.	91
LM End	9.94	Issue Type +	Ma	Location *	
Category	Supplemental			GPS Latitude/Longitude	
				Start	End
Item	DWR UCIP LMA Responsibility			37.390563 °	37.390563 °
				-120.950329 °	-120.950329 °
DWR ID					
Comment Code					
Inspector Comment					
FS_ID:24644 DS_ID:22116 EP_NO: N/A Repair Type: No Action Needed Crossing Status: Found UCIP Comments: - not very old structure. FIELD_STRUCT_DESC: 48-inch corrugated metal gravity drainage pipe through the levee and across the drainage ditch on the waterside (WS), 6 feet below the crown. Slide gate and concrete box on the WS end. Concrete box on the landside (LS) end. Installed by USACE in 1961. [Additional Reference(s): DWR Levee Log, 1992. USACE San Joaquin O&M Manual 6, September 1961, (HLM 10.11)]. FS Date: 11/6/2013

WS view: CM pipe on outlet concrete box.

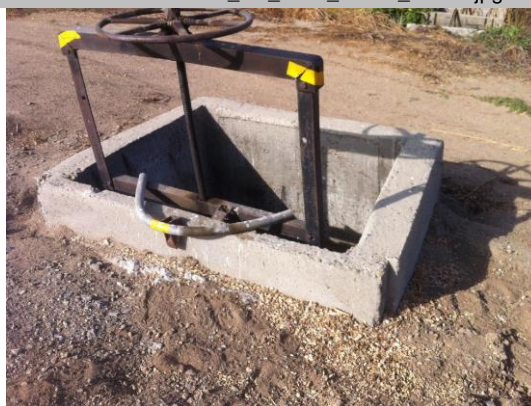
Photo 2 of 3 : UCIP_SP_2018_24644_43985.jpg

LM Start	9.94	Rating **	A/W	Issue No.	91 (cont)	
LM End	9.94	Issue Type +	Ma	Location *		
Category	Supplemental			GPS Latitude/Longitude		
				Start		End
Item	DWR UCIP LMA Responsibility			37.390563 °		37.390563 °
				-120.950329 °		-120.950329 °
DWR ID						
Comment Code						
Inspector Comment						
FS_ID:24644 DS_ID:22116 EP_NO: N/A Repair Type: No Action Needed Crossing Status: Found UCIP Comments: - not very old structure. FIELD_STRUCT_DESC: 48-inch corrugated metal gravity drainage pipe through the levee and across the drainage ditch on the waterside (WS), 6 feet below the crown. Slide gate and concrete box on the WS end. Concrete box on the landside (LS) end. Installed by USACE in 1961. [Additional Reference(s): DWR Levee Log, 1992. USACE San Joaquin O&M Manual 6, September 1961, (HLM 10.11)]. FS Date: 11/6/2013

LS view: CM pipe with slide gate on inlet concrete box.

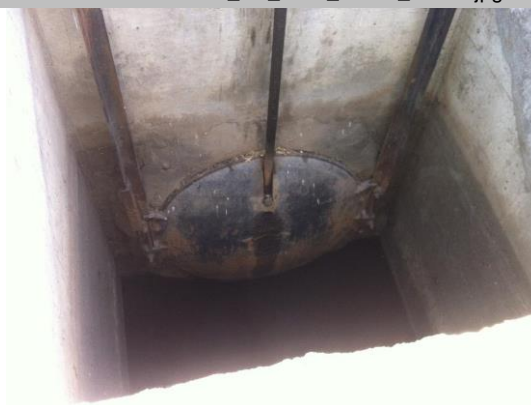
Photo 3 of 3 : UCIP_SP_2018_24644_43984.jpg

LS view: inside view of slide gate in concrete box.

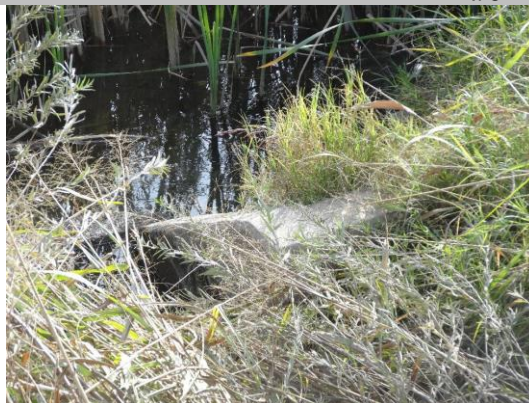
Photo 1 of 2 : UCIP_SP_2018_24645_43988.jpg

WS view: concrete U type headwall on channel bank. Not accessible.

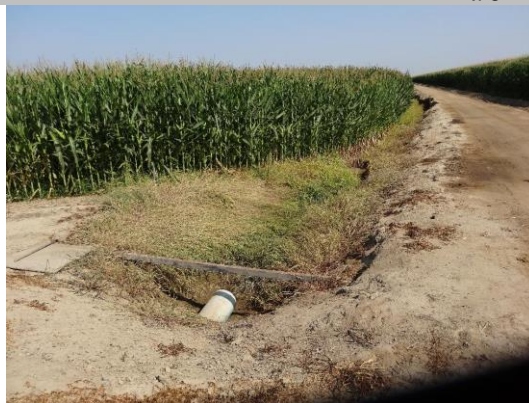
Photo 3 of 3 : UCIP_SP_2018_52539_76005.jpg

Comment Code						
Inspector Comment						
FS_ID:52539 DS_ID:22074 EP_NO: N/A Repair Type: Urgent Crossing Status: Found UCIP Comments: 09/29/2017 Received updated photos from DWR levee inspector, D. Torres, and photos show a metal cover has been added to landside (LS). The waterside (WS) pipe side remains open. This crossing remains urgent due to the WS end of the pipe open. Other issues with this crossing include compliance issues per Title 23. No permit was found authorizing this crossing. (DWR UCIP - O. Magana)08/23/2016 Same as last inspection. Recommend LMA contact owner to bring crossing into compliance per Title 23. (K. Fazel - UCIP)11/06/2013 Pipe opens on both sides of the levee. (P. Amatya - DWR) FIELD_STRUCT_DESC: 16-inch polyvinyl chloride (PVC) gravity drainage pipe through the levee, 3.5 feet below the crown. Pipe open on both ends. This crossing was field discovered. FS Date: 11/29/2017 2:48:05 PM

LS view of crossing

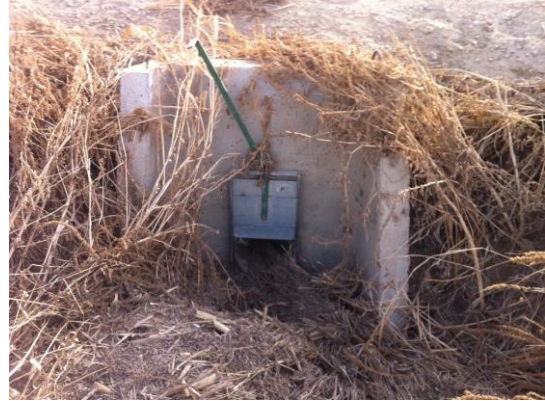
Photo 1 of 3 : UCIP_SP_2018_52540_43993.jpg

LS view: U type concrete headwall, slide gate, and pipe on levee toe.

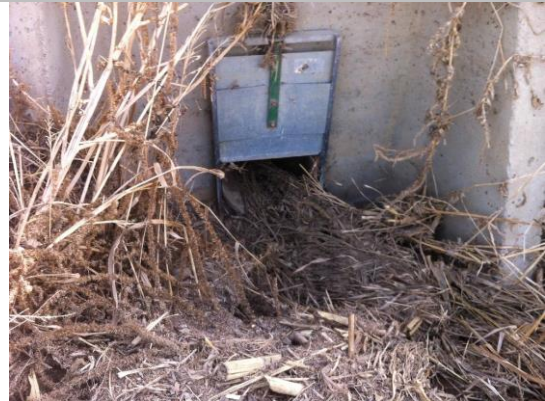
Photo 2 of 3 : UCIP_SP_2018_52540_43992.jpg

LS view: closer view of U type concrete headwall, slide gate, and pipe on levee toe.
